DYNAMIC SCIENCE, INC.
In-Depth Accident Investigation

Contract DTNH22-94-D-27058
Case DSI-95-ODI-3

1 Identification

- 1.1 Number: 3
- 1.2 Name
- 1.3 VIN: 2P4FH41
- 1.4 Year/Make/Model: 1985/Plymouth Voyager
- 1.5 Date of Accident '92
- 1.6 Location

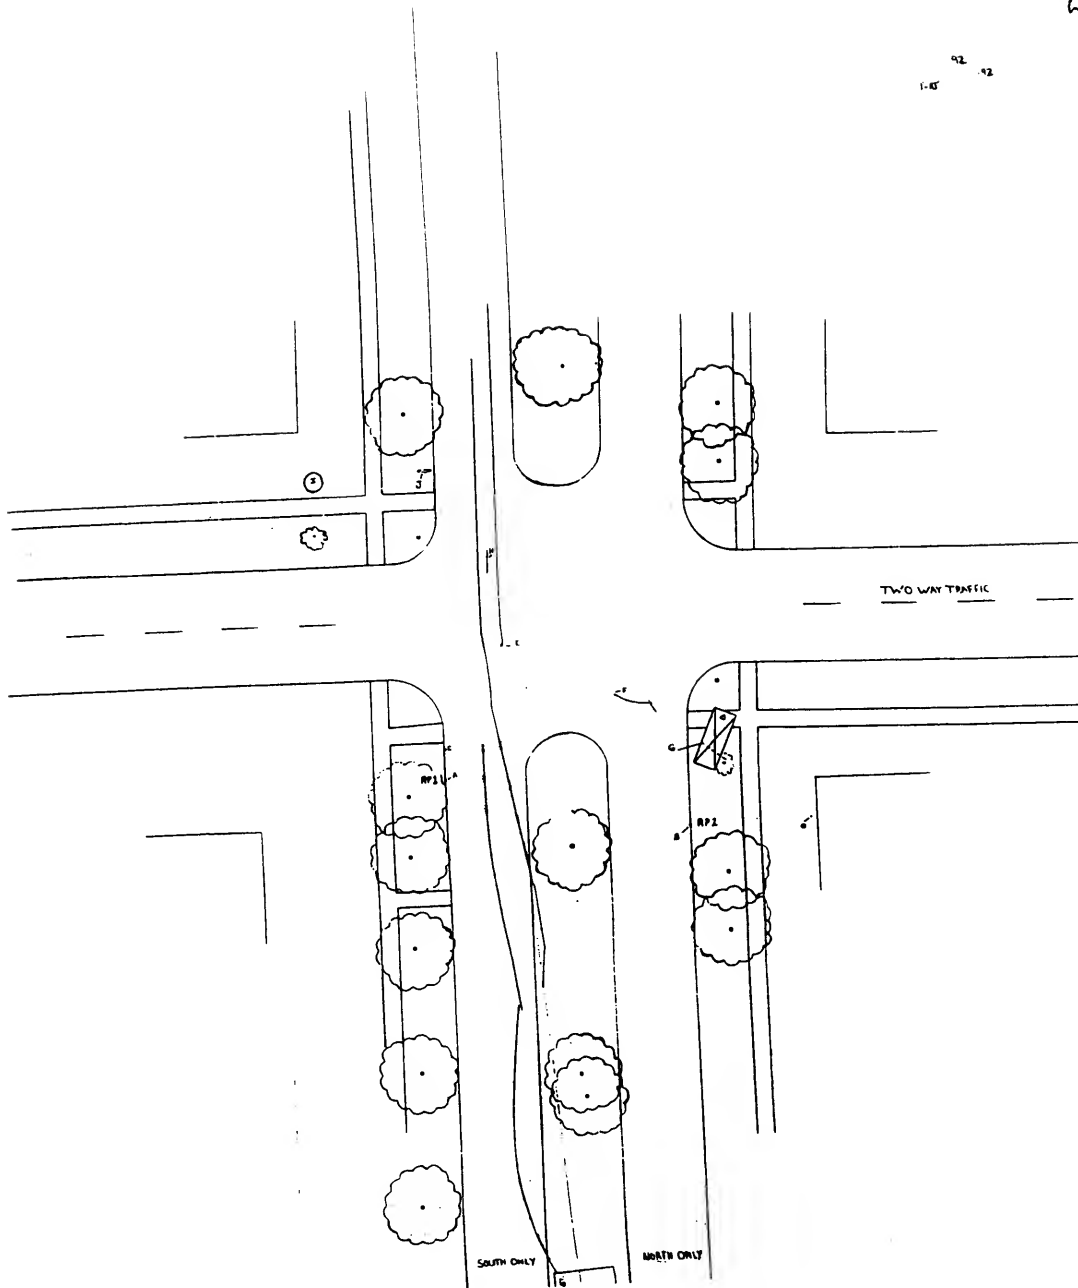
EDCRASH
At Impact

Ueh #1	Ueh #2
Delta-U (mph)		
(BASIS: Damage)		
X	-1.9	-8.7
Y	10.6	-1.5
Tot	10.8	8.8
PDOF	-80.0	10.0
